Engineering Note

Title:	Hydro-View/HC-IV intermittent shut-down
Document reference (DRC):	EN0007 issue 10
Last updated:	22/01/98
Products affected:	Hydro-Views prior to model HV02, HC-IV prior to revision C
Author:	R.E.B. Holland
Search keywords:	Hydro-View, HC-IV, PTC, fuse, shut-down, fault
Summary:	This document describes how to replace a PTC device which is known to cause intermittent shut down of a Hydro-View or HC-IV operator terminal

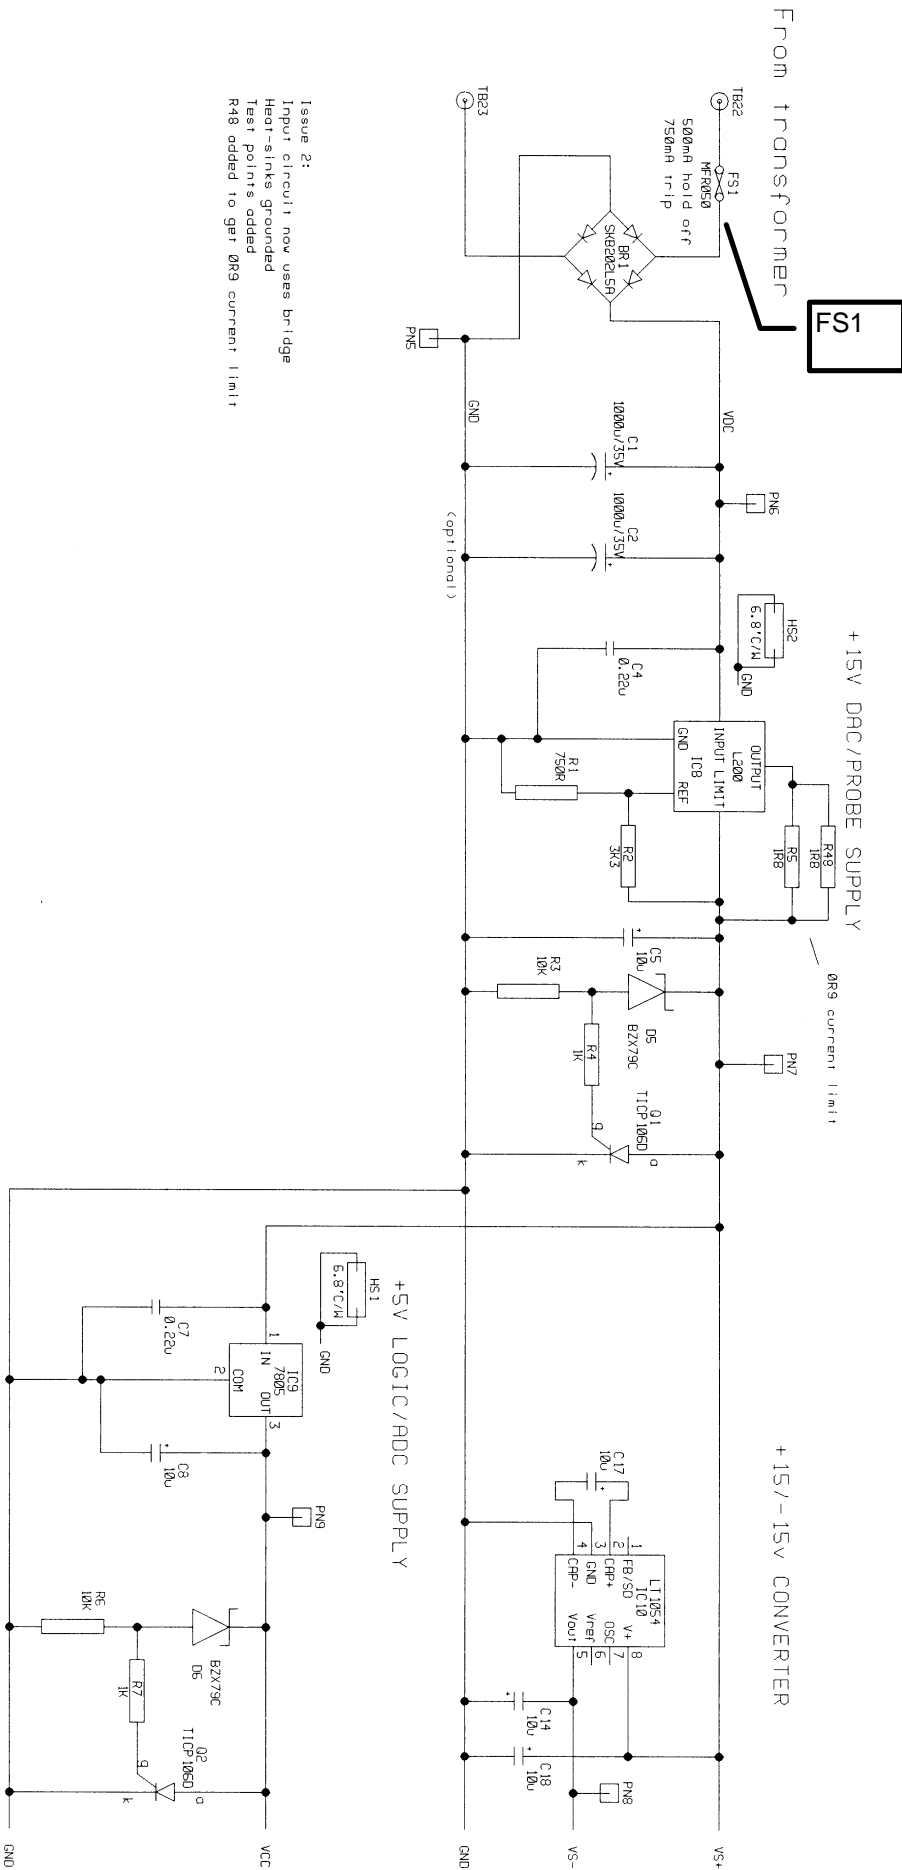
This is due to a current limiting device (Positive Temperature Coefficient (PTC) multifuse) tripping due to the high temperatures being achieved within the unit, especially with a sensor connected when the internal power dissipation is higher. We have evaluated several systems and have found that they will trip out after several hours at around 45°C ambient. Since the PTC fuse is essentially a device which exhibits a high impedance at elevated temperatures, it must either be up-rated or removed and replaced with an alternative type of device. Unfortunately, up-rating this is quite difficult if it is still to function as a current limiting device since a suitable value is unavailable.

Locate the PTC multifuse on the circuit board as FS1. This is indicated in the circuit diagram and PCB silk screen legend diagram later in this document.
