Engineering Note: EN0086 Hydro-Control V Sensor Communication Drop-Outs

Summary: Hydro-Control V and HS0089 v1.13 Sensor firmware Communications Issues

Products affected: Hydro-Control (HC05), Hydro-Mix (HM07), Hydro-Probe Orbiter (ORB02)

Revision Date: 07/07/16

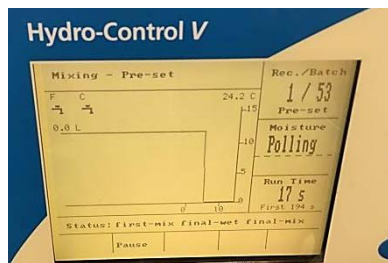
The communications failures are due to a small change in the delay time to a protocol request (potential increased delay). The potential increase in the delay time can cause some messages to be missed by the HC05 resulting in a sensor drop-out (Figure 1).

Figure 1: HC05 Sensor Drop-Out

If a sensor with HS0089 v 1.13 is connected to a HC05 it is necessary that the firmware is downgraded to HS0089 v1.11.
